**BROADCAST MESSAGE FROM THE SACRAMENTO FIRE MARSHALL
TO A FIRE MARSHALL'S LIST SERVER:**

Explosion In Rancho Cordova
March 20,2001
10980 Gold Center Dr, Rancho Cordova

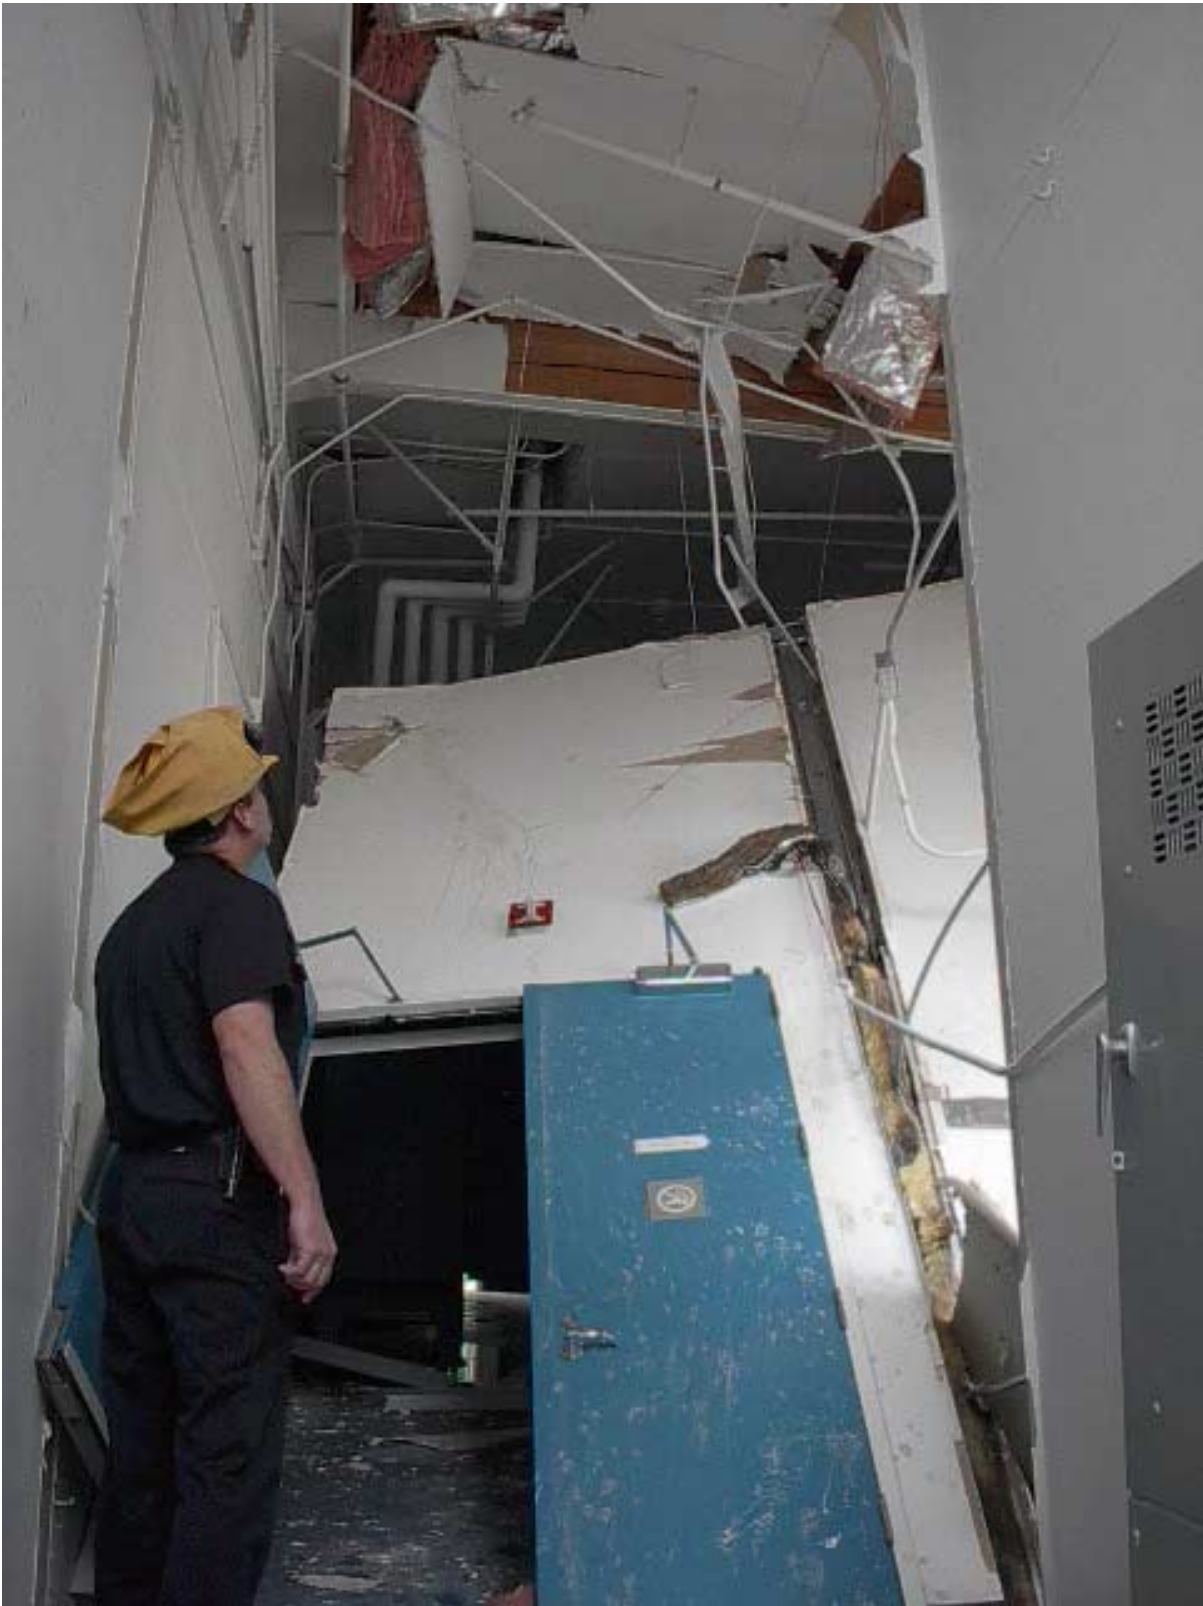
Thought some of you might be interested in this picture. It is a hydrogen explosion in a UPS/battery room we had here in Sacramento this week. It is a very good example of what happens if you lose ventilation in a battery charging room. The explosion blew a 400+ sq.ft. hole in the roof (notice the sky above in the picture), collapsed numerous walls and ceilings throughout the building, and significantly damaged a large portion of the 50,000+ sq.ft. building. Fortunately the computer/data center was vacant at the time, so there were no injuries. I have more pictures/info, if interested just let me know.

The lesson to pass on, is that ventilation is critical in these facilities. Great care should be taken to ensure ventilation is adequate, or even better that the batteries can not be charged without the ventilation system properly working. To complicate matters, the codes are not really helpful in these facilities - UFC Article 64 requires that continuous ventilation be provided or that system is designed in accordance with ANSI-IEEE 484. IEEE 484 unfortunately is very vague, does not prescribe set levels of ventilation, does not require interlocks, and even allows natural ventilation. IEEE 484 also specifically exempts the space from being a Classified (hazardous) electrical

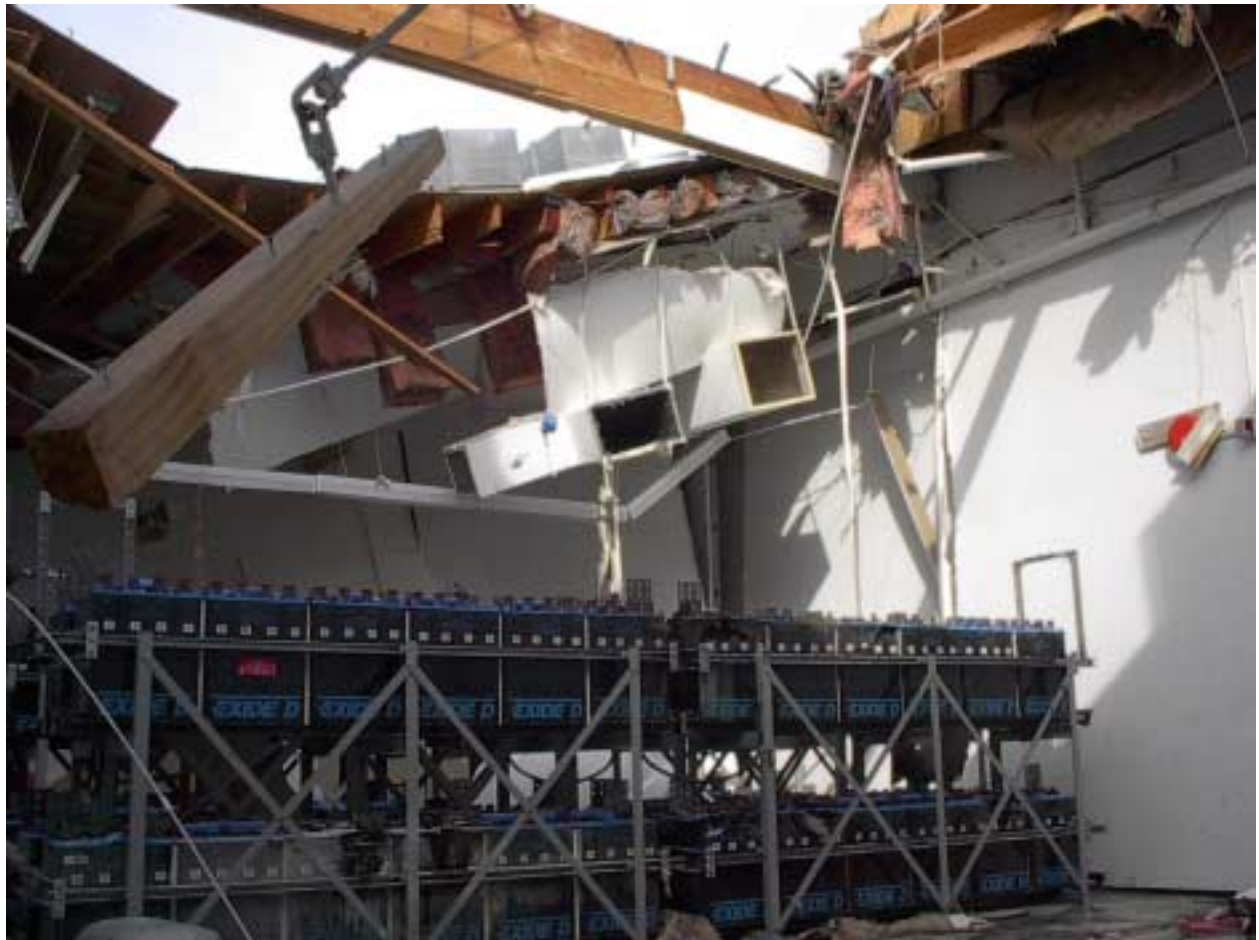
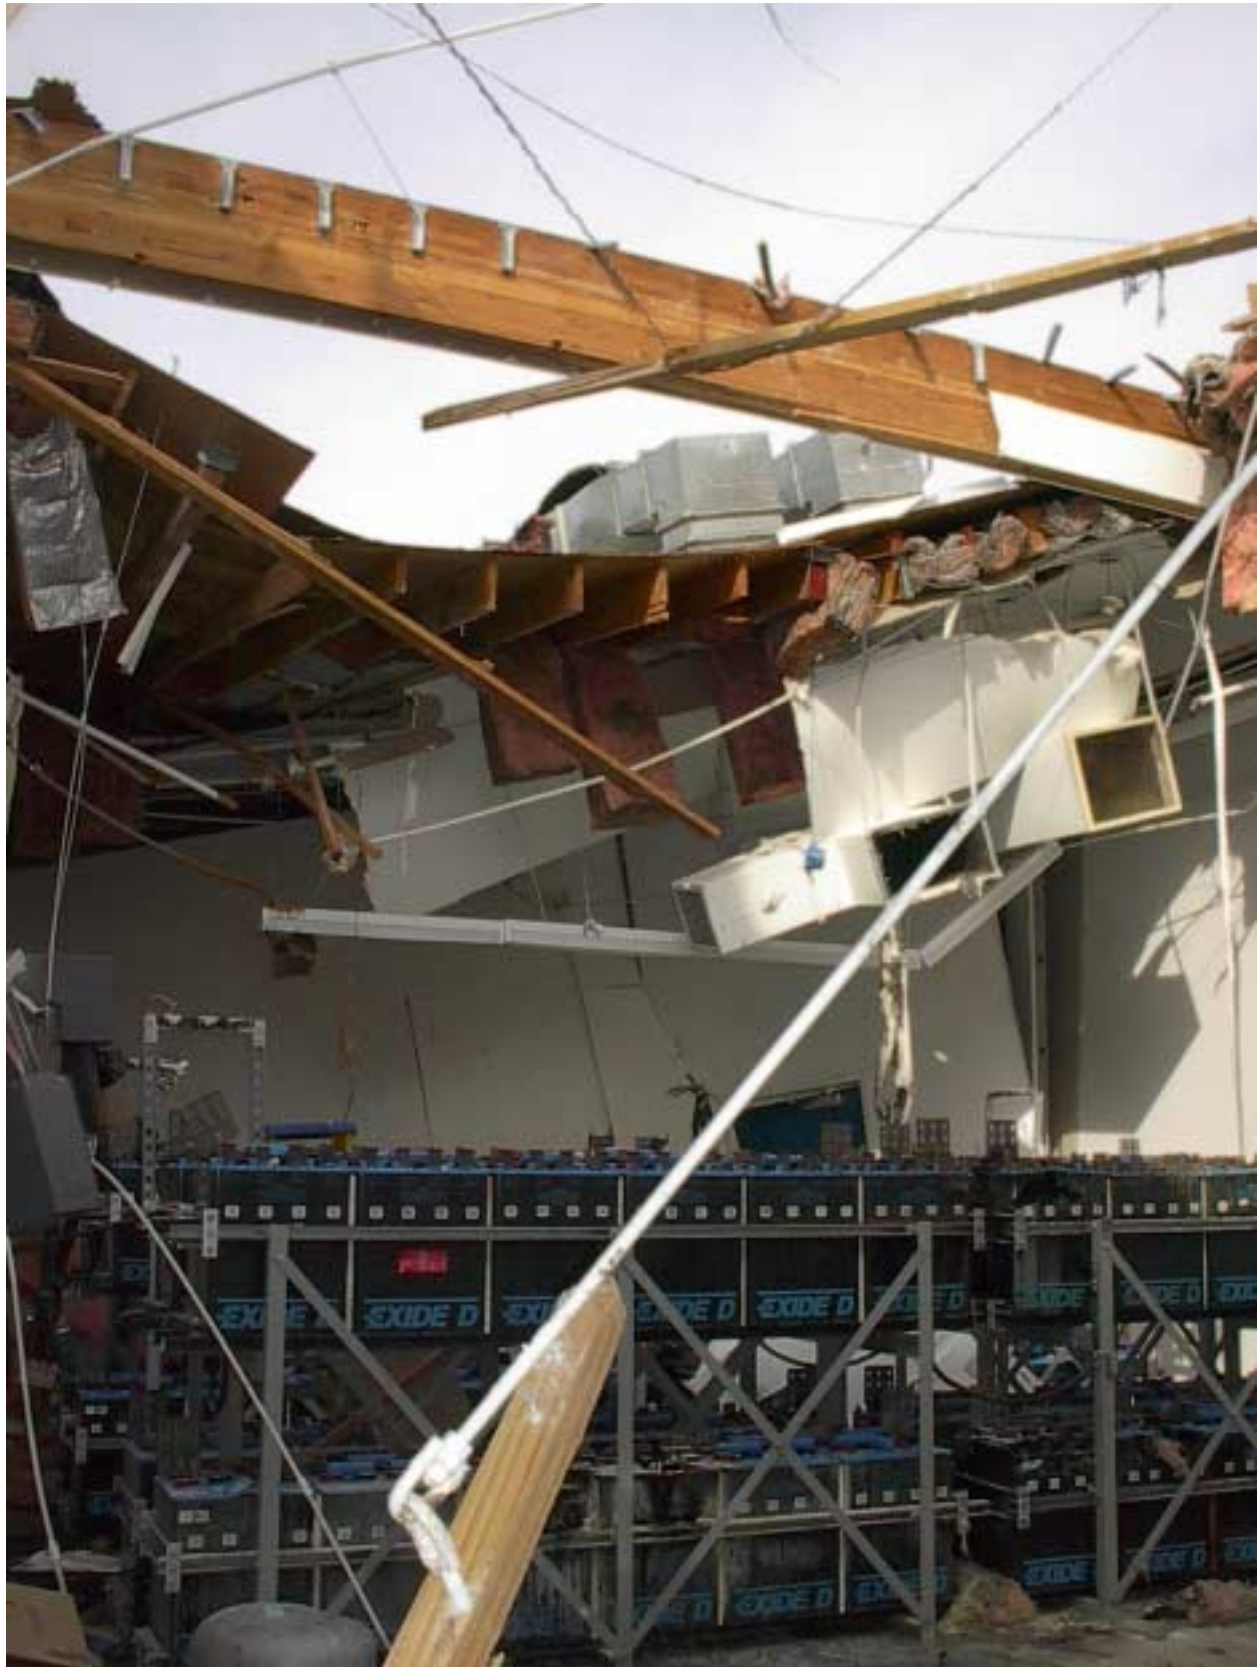
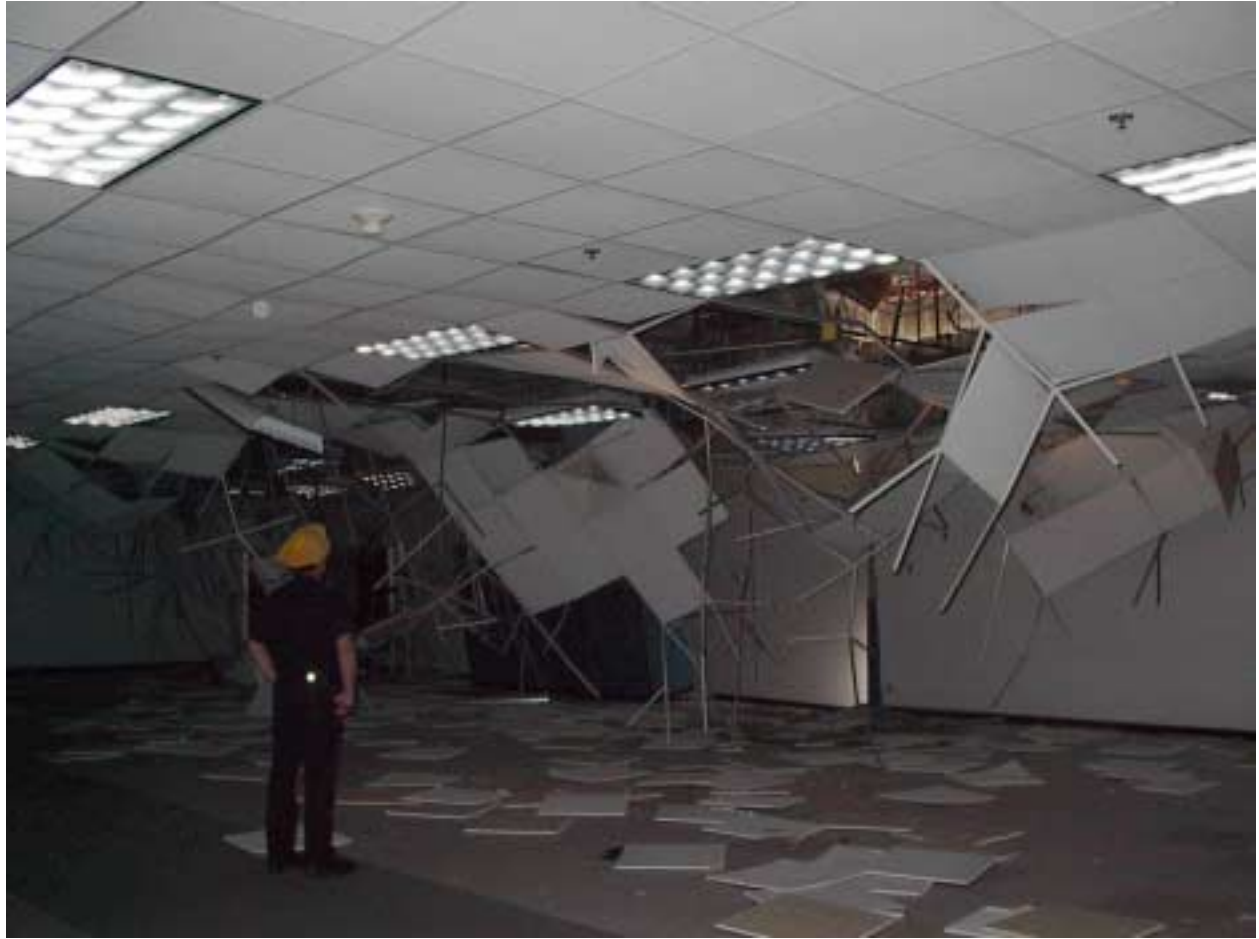
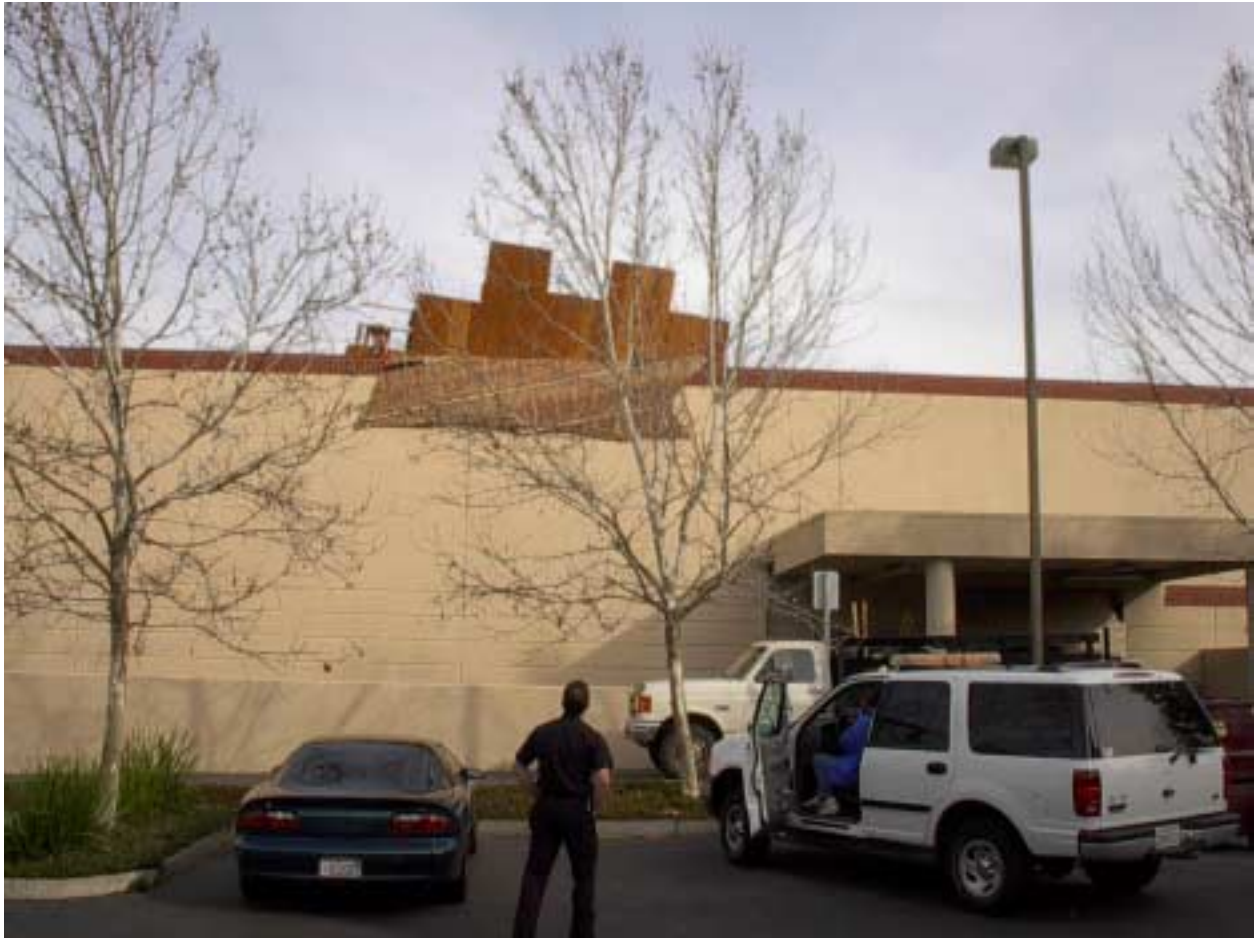
2:41 pm Metro Firefighters responded to a report of a building explosion. When the battalion Chief arrived on the scene he reported a large portion of the roof missing and large steel roll up door with a large hole in it. The Chief requested a second alarm to the scene.

When Firefighters entered the building they found several walls blown over and visible smoke from a room that housed several large batteries. Firefighters also reported that a 40-foot section of the roof was missing just over the area of the explosion. The building was searched for possible trapped victims, and none were found.
