Thermal Vision	*Inspected Equipment:* **Swichfuse**	*Operator:* Bob Berry

Thermal Vision	*Inspected Equipment:* **Dist Board KP**	*Operator:* Bob Berry

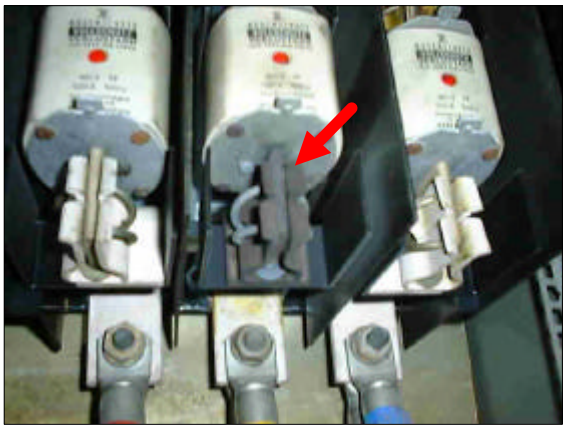
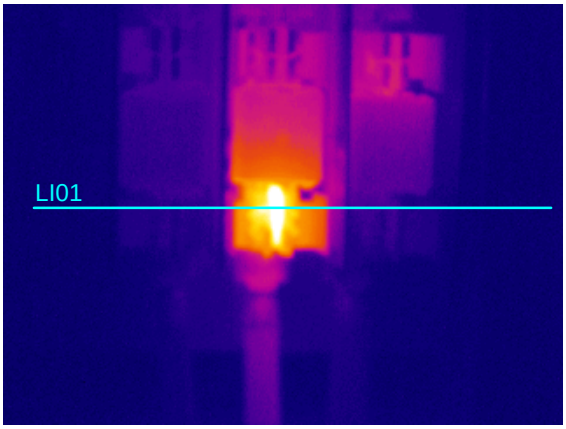
Section	Main Swichroom
Equipment	Swichfuse
Additional information	PF Correction
Date	11-12-1998
Time	09:31:23

Fault	Bad connection

Object parameter	**Value**
Emissivity	0.90
Object distance	1.5 m
Label	**Value**
LI01 : max	227.0°C

This item requires immediate atention, the corrosion is apparent on opening the panel. I would suggest replacing the swichfuse rather than attempting a repair. It would also be advisable to replace the cables on the bottom connection of the center phase

Replace

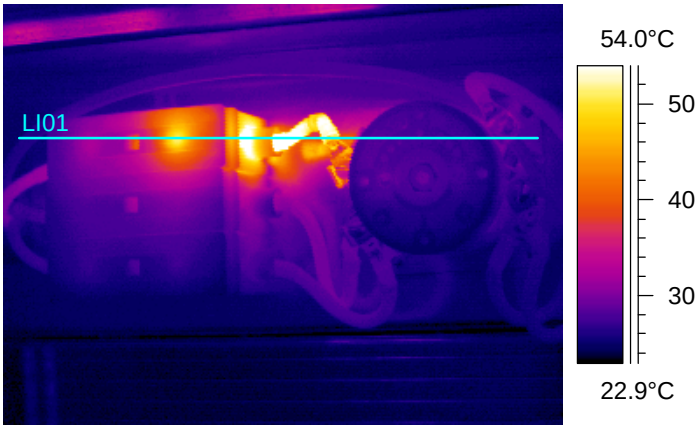
Section	Boiler house
Equipment	Dist Board KP
Additional information	
Date	15-06-1999
Time	11:02:46

Fault	Bad Connection

Object parameter	**Value**
Emissivity	0.89
Object distance	2.0 m
Label	**Value**
LI01 : max	60.6°C

Repair

Check connections remake if necessary. Check condition of fuse, carrier and cap and replace if there are any signs of deterioration.

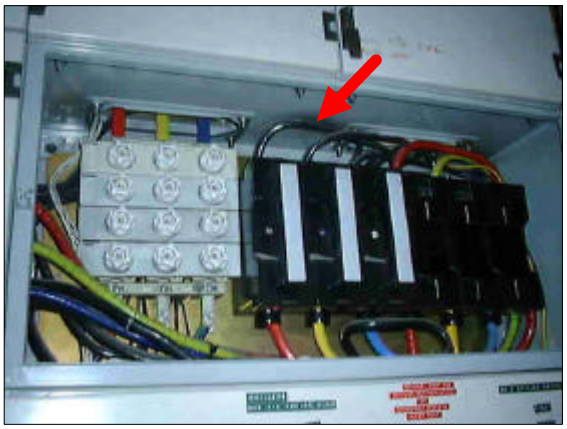
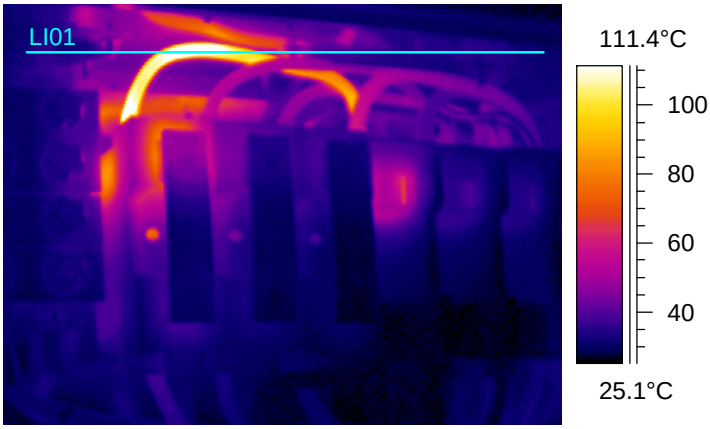
Section	Corridor
Equipment	Dist Board EGP
Additional information	Freeze Dryer
Date	15-06-1999
Time	11:59:15

Fault	Bad Connection

Object parameter	**Value**
Emissivity	0.89
Object distance	2.0 m
Label	**Value**
LI01 : max	124.0°C

Repair or Replace

Check connections remake if necessary. Check condition of fuse, carrier and cap and replace if there are any signs of deterioration.

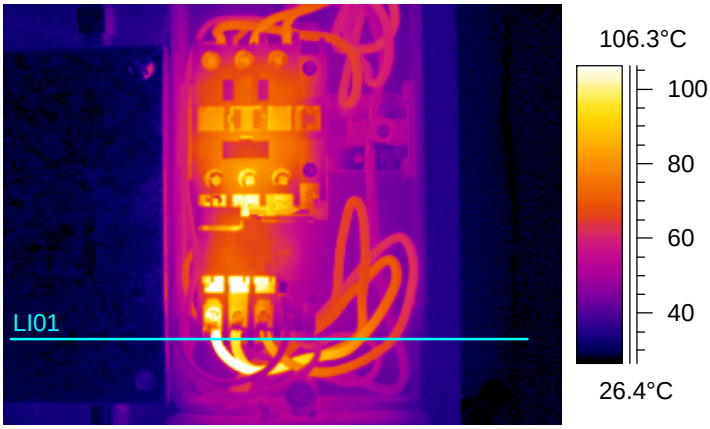
Section	Mould shop
Equipment	Chill water system
Additional information	Pump no 2 contactor
Date	28-06-1999
Time	12:14:29

Fault	Overheating

Object parameter	**Value**
Emissivity	0.86
Object distance	2.0 m
Label	**Value**
LI01 : max	130.5°C

Repair or Replace

Check connections remake if necessary. Check condition of all components and replace if there are any signs of deterioration. Load testing all phases would also be recommended. If no explanation for the temperatures is found then this item should be replaced with a more suitable starter.
